Graphite Reactor Decommissioning

Michelle Wise
Head, Technical Services Group,
UKAEA

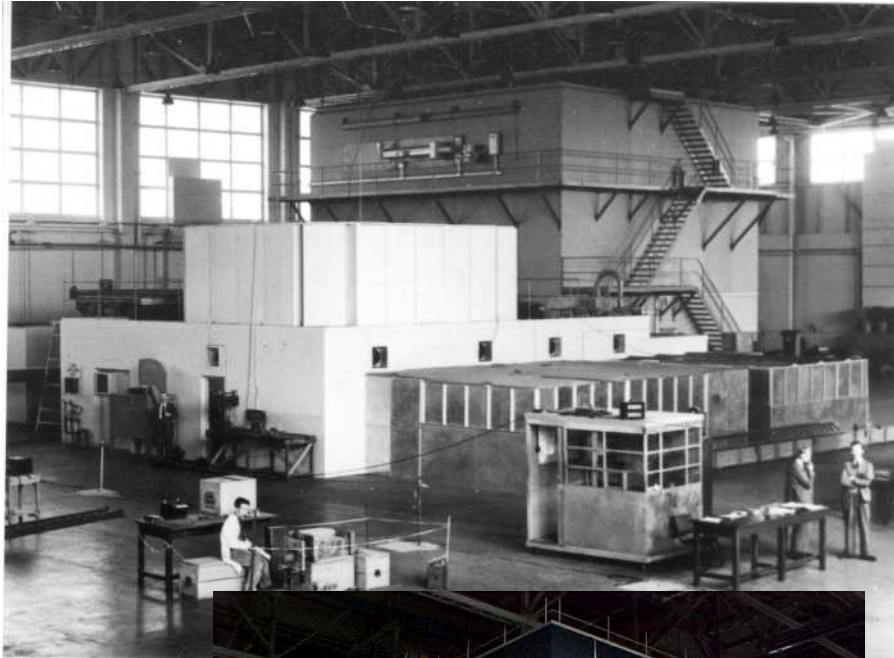
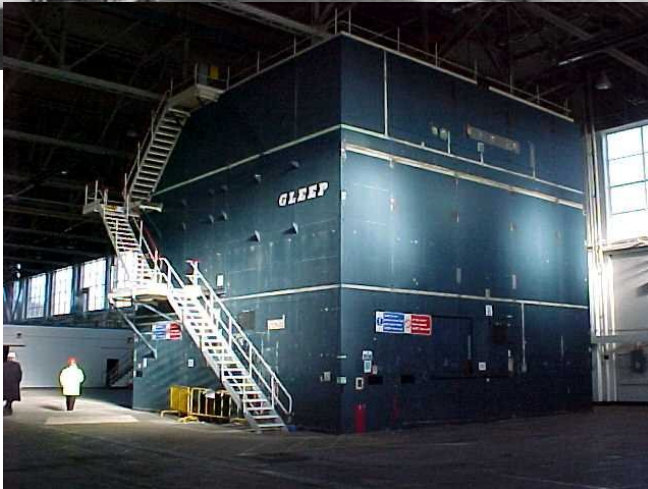
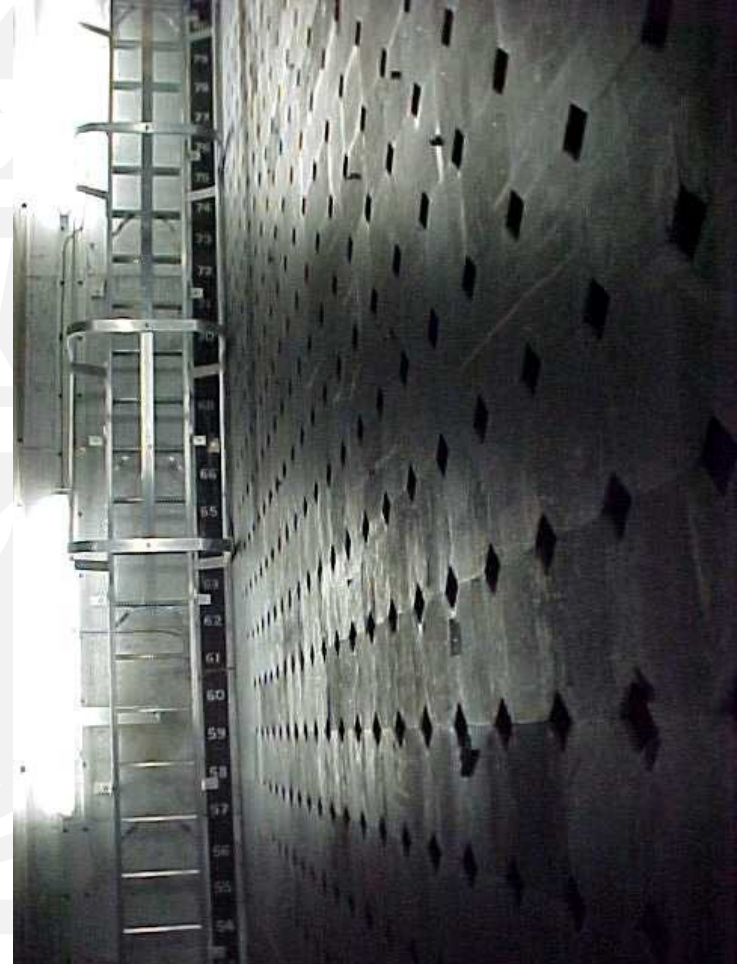
GLEEP reactor

- First reactor in Western Europe – built in the mid-1940's and started operating in August 1947
- Used for experimental studies and calibrations
- Graphite cube of 6.4 m sides, 505 t of graphite
- 682 fuel channels – natural uranium/Al clad
- Core shielded by 1.5 m of barytes concrete
- Initially operated at 60 kW(th) for a year but then operated at 3kW(th) until closure
- Average operating temperature of 18 °C
- Shutdown in 1990 after 43 years of operations.

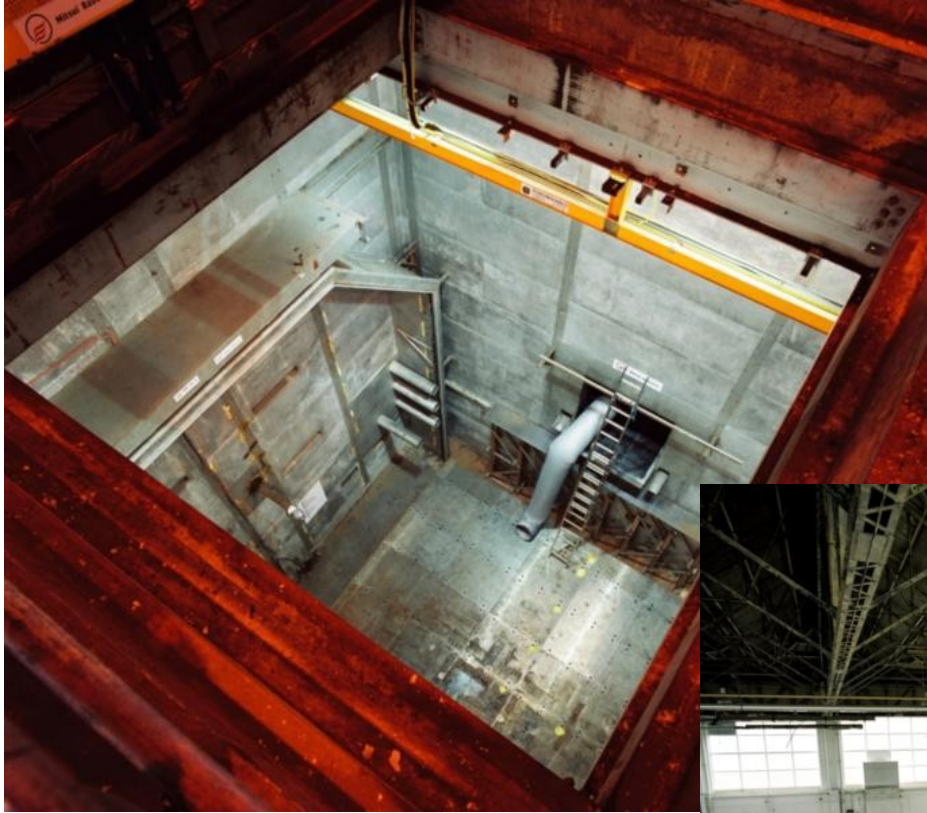
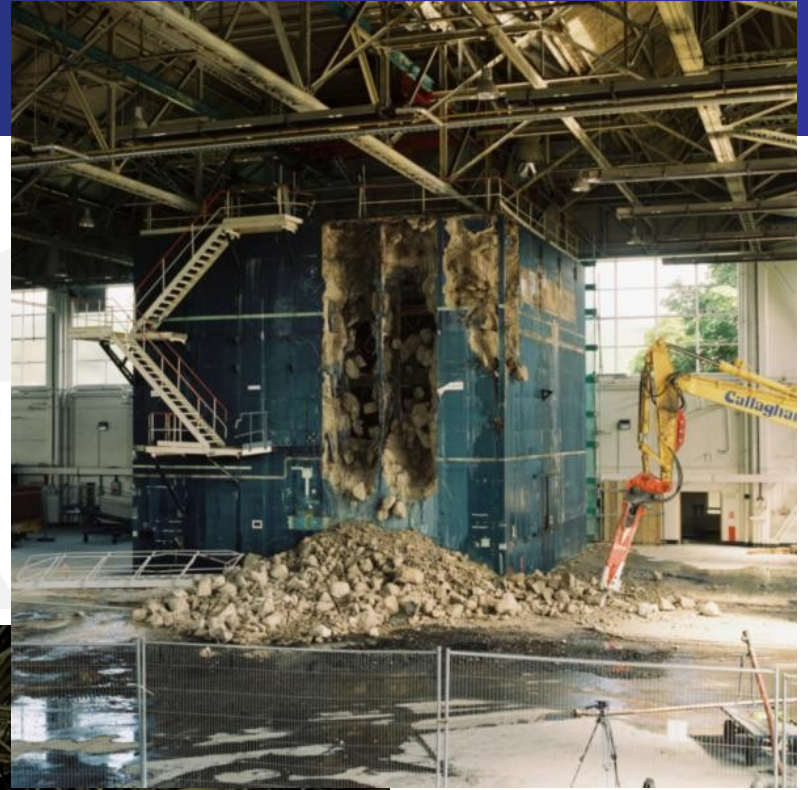
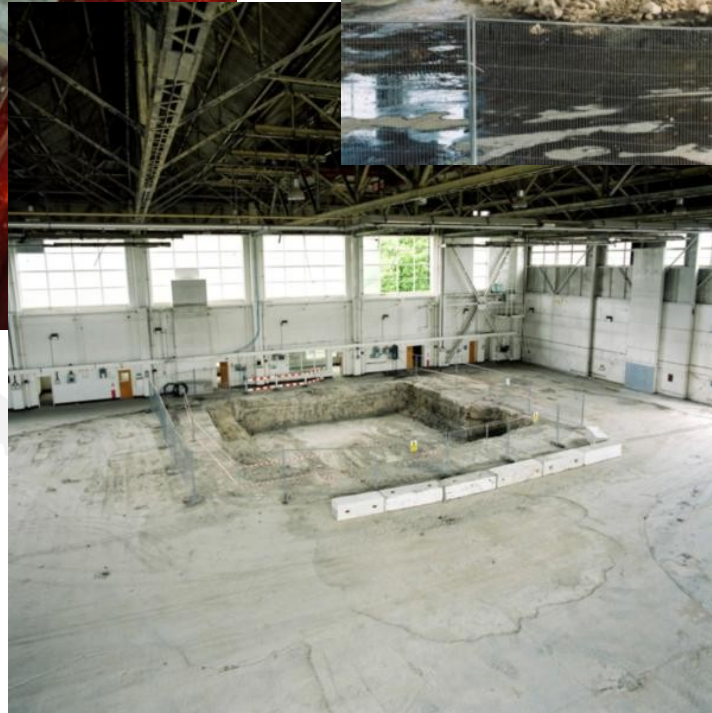
GLEEP decommissioning

- Defuelling performed in 1994
- Control rod and external equipment removal in 1995
- Brick by brick removal of the graphite core in 2003-2004, using the 'drill and tap' method
- Demolition of the concrete bioshield
- Hangar demolition and land remediation
- Land currently undergoing de-licensing scrutiny by the NII

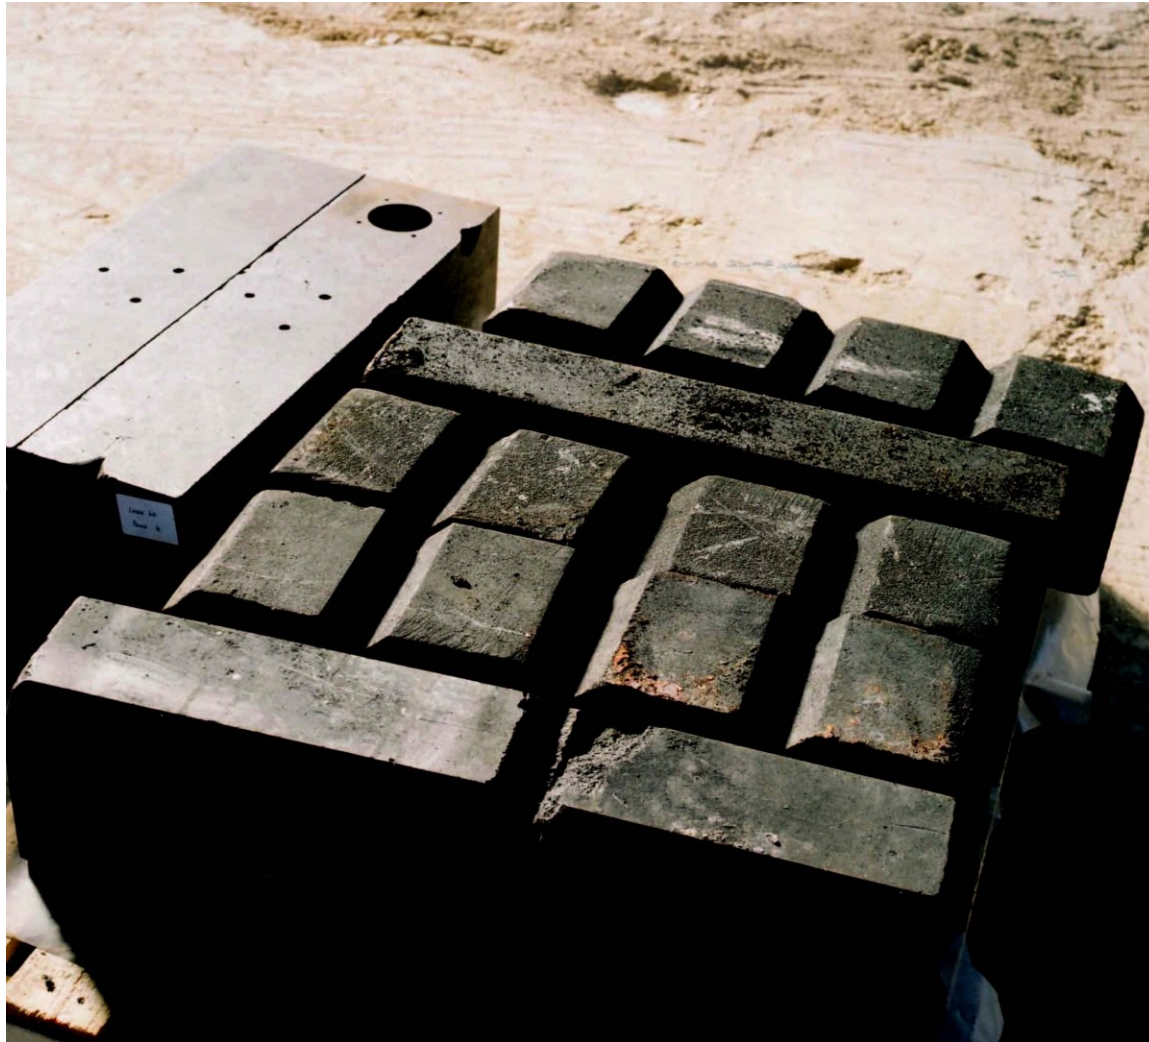
Graphite incineration

- Each graphite block was monitored and sampled on removal and tagged for inventory tracking purposes
- Blocks were then crushed and packaged into 200 litre drums
- Crushed graphite then incinerated to drive off H-3 and C-14
- Aerial discharge of tritiated water vapour and C-14 carbon dioxide several orders of magnitude under discharge authorisation
- Incineration was significantly cheaper than packaging the graphite for disposal at the LLWR near Drigg

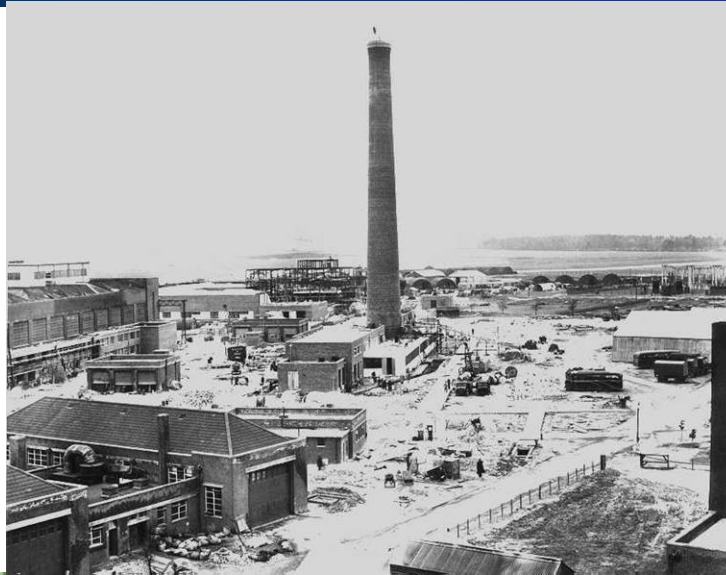
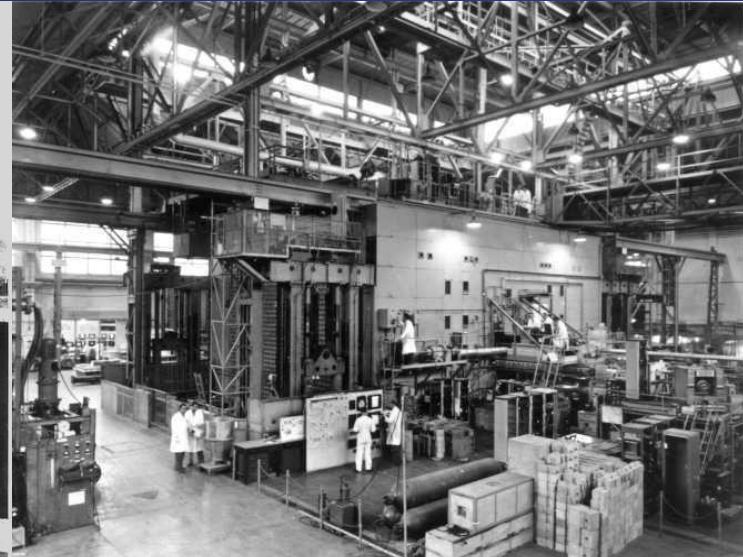
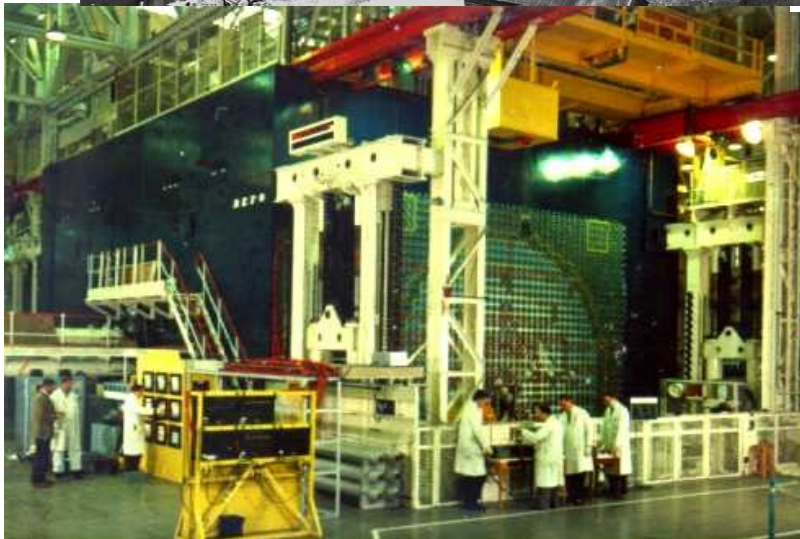
BEPO – construction and operation

- Following the success of GLEEP BEPO was constructed at Harwell in the 1940's
- BEPO started operation in July 1948
- Used to demonstrate that commercial power reactors would be viable, materials testing and production of radio-isotopes
- Graphite cube of 7.9 m sides, 766t of graphite
- 888 fuel channels – natural uranium/Al clad
- Operated at 6kW(Th)
- Shutdown in 1968.
